## SOLAR VALUATION REPORT

# What the solar on this home is worth today

Sample property, North Phoenix, AZ 85086

SVR-2026-0001

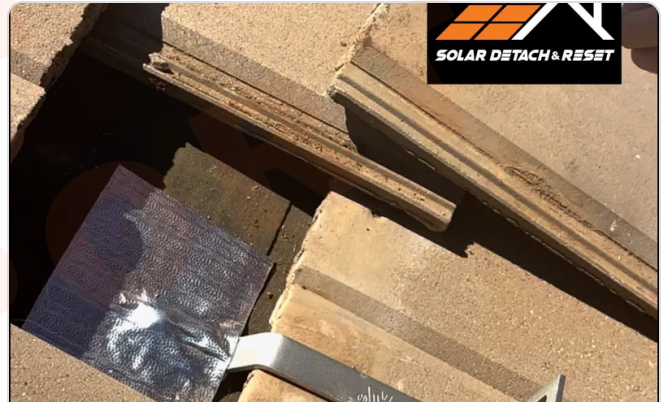
Representative mount: flashing and sealant intact

| COMPONENT | CONDITION | FINDINGS |
|---|---|---|
| Roof, mounts and penetrations | Good | All 24 accessible mounts flashed and sealed; sealant on 3 mounts at the ridge row aged but intact; no staining below deck. Two cracked tiles adjacent to the array, not under it. |

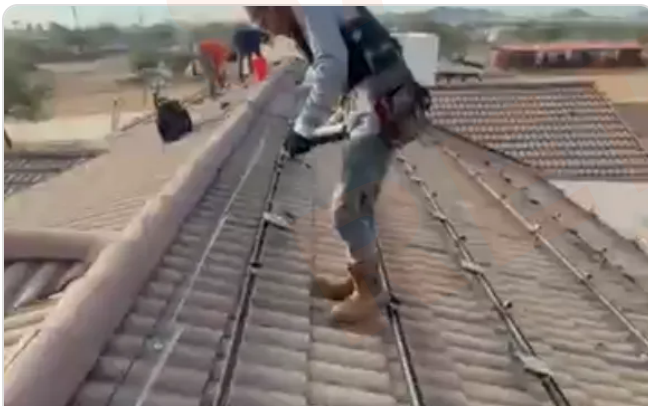
| COMPONENT | CONDITION | FINDINGS |
|---|---|---|
| Wiring, connectors and racking | Good | Conductors secured in rail clips; no sag, no rodent or bird damage; grounding continuous. Rail clamps at torque. |

Racking, conductor routing and clamps inspected on the roof

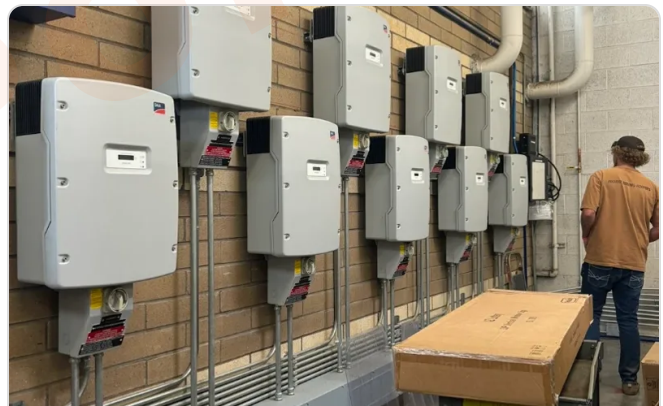
| COMPONENT | CONDITION | FINDINGS |
|---|---|---|
| Inverter and disconnects | Fair | Original 10-year-old string inverter; no active faults; fan noise within normal; replacement expected within 3–5 years. AC/DC disconnects labeled and operable. |

Inverter tested under load; age and fault history recorded

- Budget for inverter replacement within 3–5 years (approx. \$3,500–\$4,000 installed). Disclose to buyer.
- Replace the two cracked tiles adjacent to the array (minor, under \$300).
- Install bird guard as a preventive measure on this tile roof (quote available).
- Annual inspection and cleaning recommended; SolarCare Plan covers both visits.
